**SAMPLE  
REPORT**

## Residential Home Inspection

123 Old Fashioned Tree Rd

Sample property | Inspection date: August 14, 2026

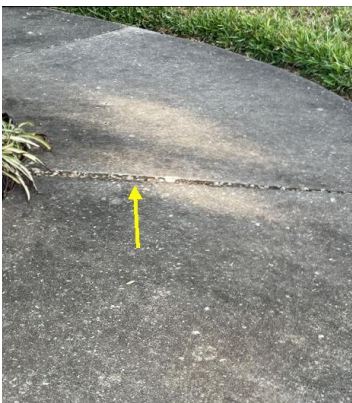
The walkway has significant large and displaced cracks, which could pose potential safety concerns. Additionally, both the driveway and walkway surfaces have areas of raising or settling, creating noticeable trip hazards.

Driveway/Walkway surface was raised/settled.  
Trip hazard noted.

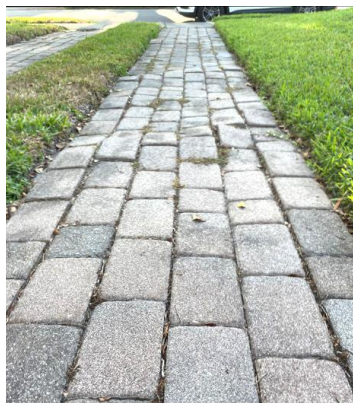
Driveway/Walkway surface was raised/settled.  
Trip hazard noted.

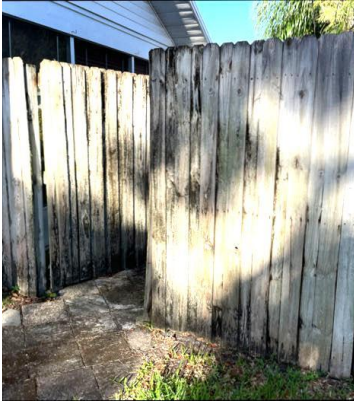
During the inspection, it was observed that the fence and gate(s) are in a state of disrepair. The fence exhibits visible damage that could potentially compromise its integrity and security. Additionally, the gate(s) require adjustments or repairs due to visible damage, which affects their proper functionality and alignment. Immediate attention to these issues is advisable to ensure the safety and privacy of the property.

Fence was damaged.

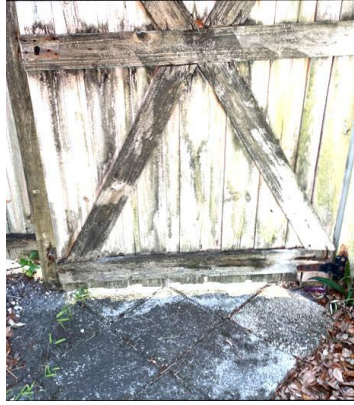
Gate was damaged

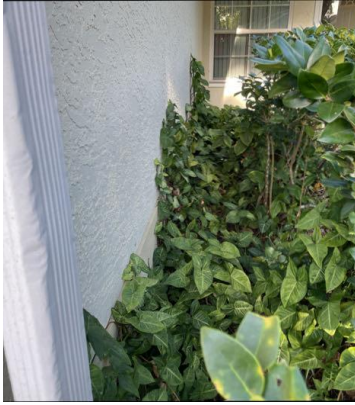
The landscaping and vegetation around the property are poorly maintained and overgrown, which may lead to potential issues such as moisture retention near the foundation. Additionally, there are two large tree stumps present in the front yard, which could contribute to future foundation concerns if not addressed.

Landscaping and vegetation was poorly maintained and overgrown.

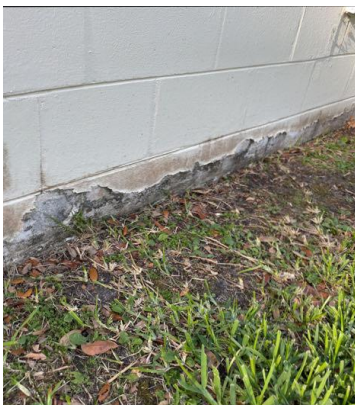
The exterior walls show signs of wear, with areas where paint is peeling or fading. Regular maintenance is important, and it would be beneficial to consider painting in the near future to preserve the integrity and appearance of the home's exterior.

Paint is peeling at the ground

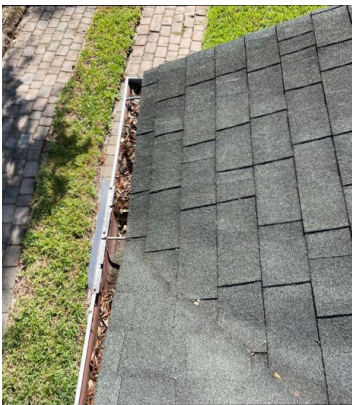
The gutters are currently filled with debris, and the downspout drains appear to be blocked. This condition could impede water flow and potentially lead to water damage or overflow issues. Regular cleaning and maintenance are necessary to ensure proper drainage functionality and to prevent further complications.

Gutters were filled with debris and the drains were blocked.

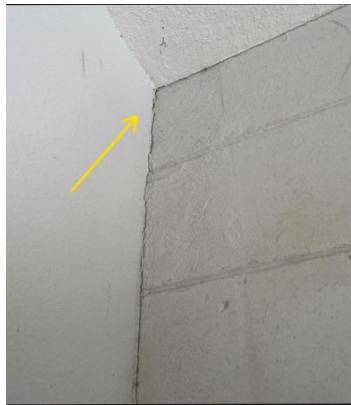
Settlement cracks up to 1/8" in width were observed. These cracks are often a result of normal settling over time and are generally common in concrete structures. While they currently do not pose a significant concern, it is important to monitor these cracks for any potential changes in size or appearance, which could indicate more significant structural issues.

Settlement cracks

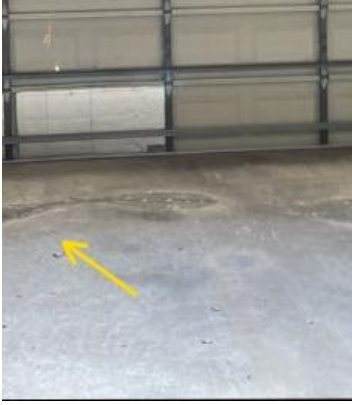
Observed some staining on the garage floor; source and impact can not be determined, but it appears to have come from a leaking vehicle.

Stainging on garaga floor

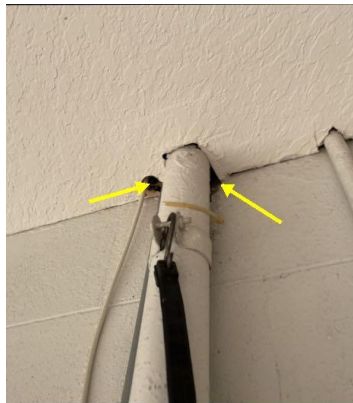
Ceiling seam separation was visible, which could compromise the fire-resistance capabilities of the structure. Additionally, the attic pull-down ladder is not fire-rated, which may pose a risk in the event of a fire. Holes/gaps should be repaired with a fire-rated material.

Holes/gaps should be repaired with fire-rated material.

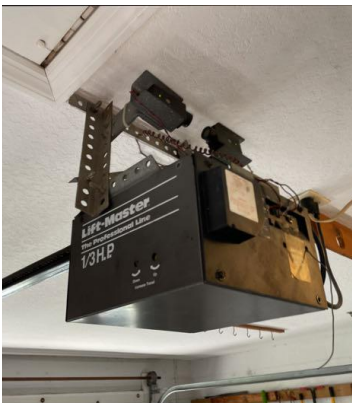
During the inspection, it was observed that the electronic eye safety feature of the garage vehicle door opener did not operate as expected. Additionally, electronic eyes were missing or not installed. Though operational at the time, the door opener has reached or exceeded its useful life and may require replacement soon.

Electronic eye safety feature did not operate when tested.

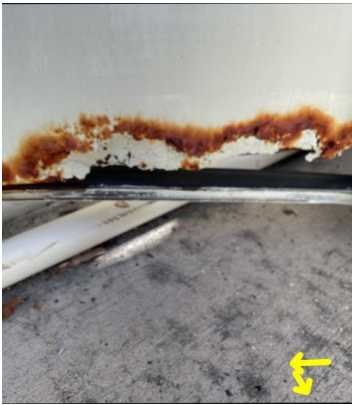
Moisture damage was observed on both the door and door jamb. Additionally, the lock was found to be damaged. These issues may compromise the door's functionality and security. Further assessment might be needed to determine the extent of the moisture impact and necessary repairs.

Moisture damage was visible at the door and/or door jamb.

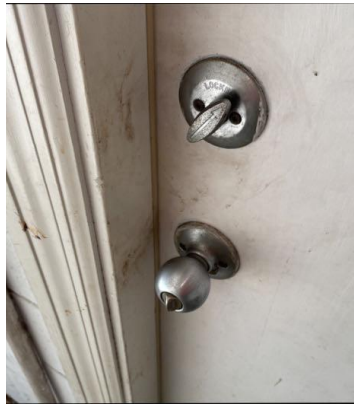
Lock was damaged.

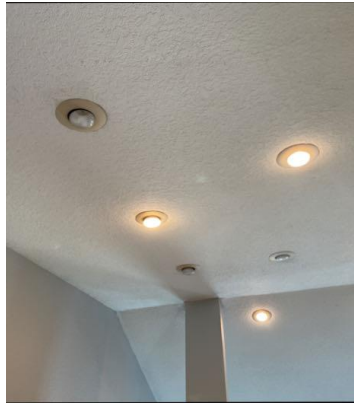
Several lights were tested but found to be non-operational at multiple locations within the property. Additionally, it was noted that some exterior outlets were not functioning.

Light(s) were tested and not operational at multiple locations.

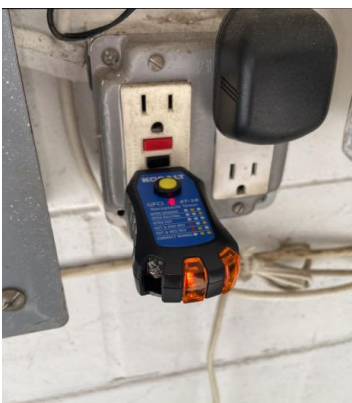
The bathroom GFCI reset outlet is located in the garage, which may lead to inconvenience. Additionally, weatherproof covers at the exterior outlets were either damaged or missing and the garage GFCI outlets were found to be damaged as well, potentially affecting the safety and functionality of the electrical system in that area.

GFCI (Ground Fault Circuit Interrupter) outlet(s) was damaged at garage outlets.

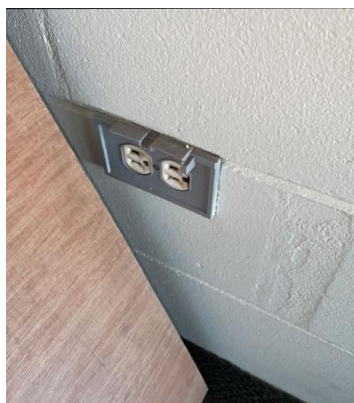
Weatherproof covers were damaged/missing at exterior outlet(s).

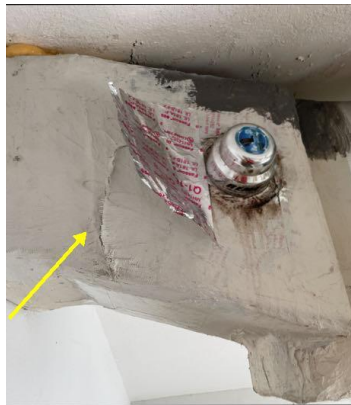
The heating system is operational but is approaching or has exceeded its useful life of 10-15 years, indicating potential replacement needs in the near future. Additionally, there are gaps or damage at the plenum that require sealing to ensure optimal performance and efficiency.

Gaps/damage at the plenum should be sealed.

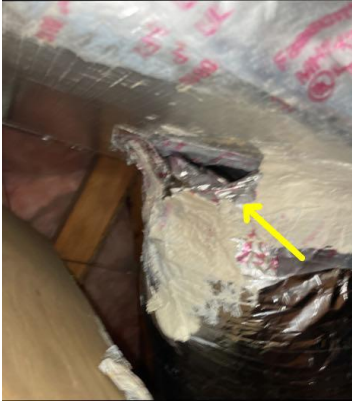
Air leaks detected at visible connections in the heating system distribution.

Air leak

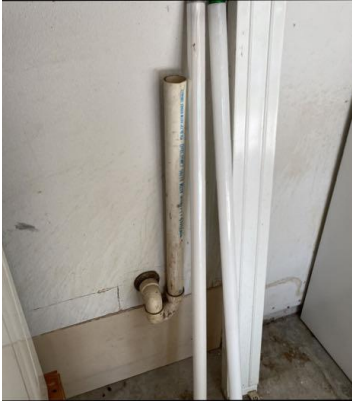
There is an unused sink drain in the garage with a dry trap, which can allow sewer gases to escape. However, all visible drain lines were found to be in good condition.

Unused sink drain in garage should be capped - dry trap, will allow sewer gases to escape.

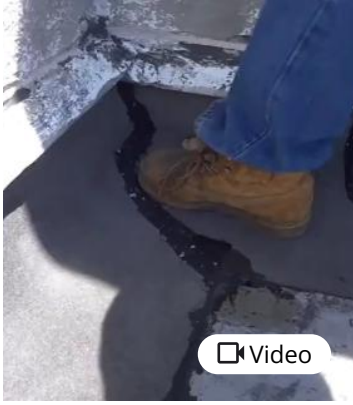
During the roof inspection, damaged and loose roofing materials were observed in multiple locations. These issues can potentially lead to water intrusion and further structural damage if not addressed promptly. It is recommended that a qualified licensed roofer evaluates and repairs these areas to ensure the roof's integrity and longevity.

Roof water damage

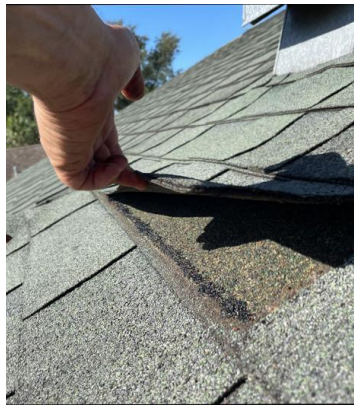
Loose shingles near vent flashing

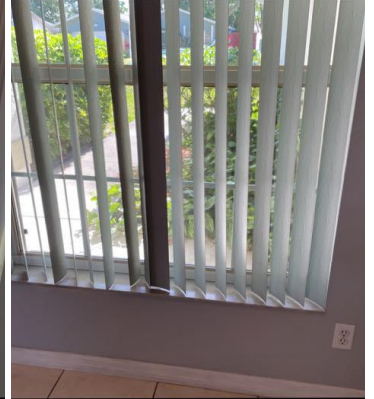
The window tension springs were damaged in multiple locations, potentially affecting the functionality and safety of the windows. Additionally, several locks in the family room were either missing or damaged, which may compromise security in this area.

Window tension spring(s) were damaged - kitchen

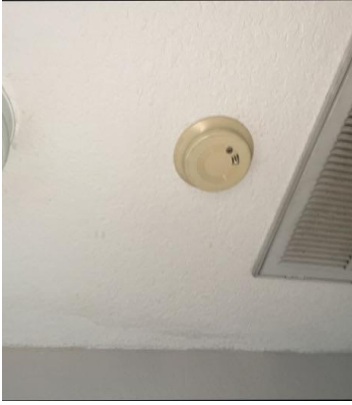
During the inspection, it was noted that smoke detectors were missing in several required areas, compromising safety. Additionally, CO detectors were not present, which is a crucial safety feature. The smoke detector in the hallway failed to respond when tested, indicating a potential malfunction.

Smoke detector(s) did not respond when tested at Hallway

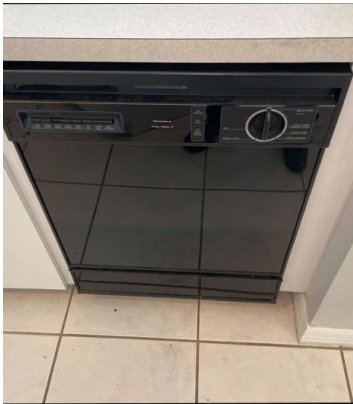
The kitchen dishwasher did not function under normal operating conditions during the inspection. It failed to initiate a wash cycle when tested.

Dishwasher not operable

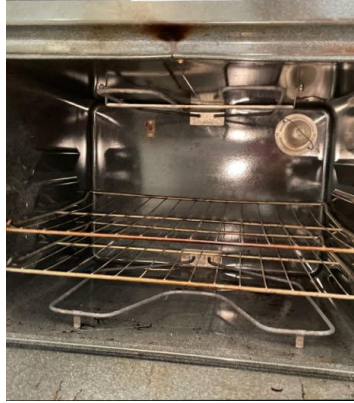
Oven was not functioning properly. No broiler. No Light

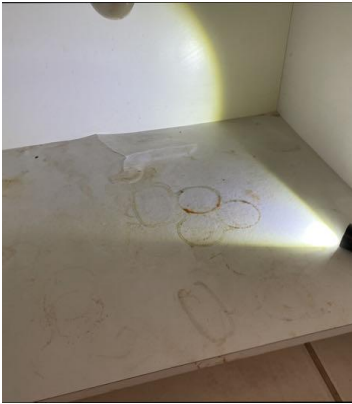
Visible dry stains were observed under the sink in the hallway bathroom. This indicates a possible previous leak or spill that has since dried. While no active leaks were detected

Dry stain(s) were visible under sink at hallway bathroom

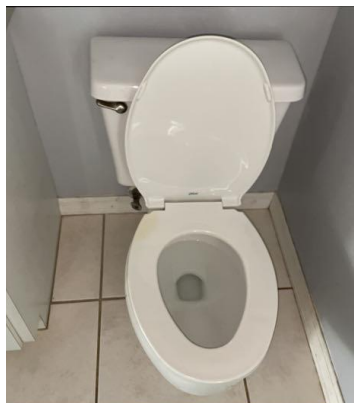
All bathrooms have toilets that are loose at the floor. This indicates a potential issue with the stability and may lead to leaks or damage if not addressed. It's important this condition be reviewed further to ensure proper function and integrity of the seal and flooring.

Toilet was loose at the floor at all bathrooms

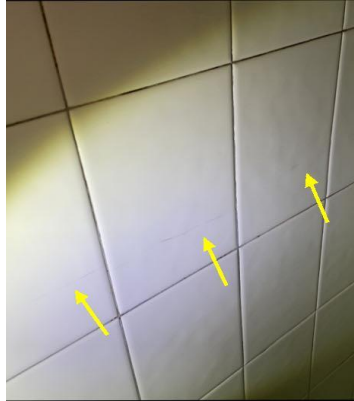
All bathroom shower enclosures require caulking or grouting to ensure proper sealing. In the primary bathroom, cracked tiles were observed, which may indicate potential water intrusion issues. Additionally, there is damage to the wall at the exterior of the shower enclosure in the primary bathroom, necessitating attention to prevent further deterioration.

Cracked tiles were visible at primary bathroom

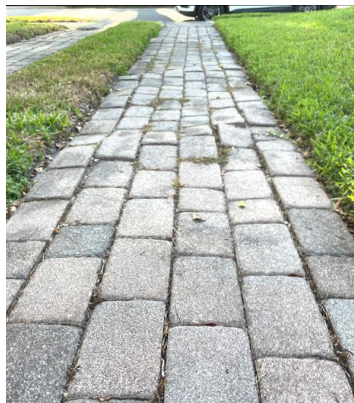
The walkway has significant large and displaced cracks, which could pose potential safety concerns. Additionally, both the driveway and walkway surfaces have areas of raising or settling, creating noticeable trip hazards.

Driveway/Walkway surface was raised/settled.  
Trip hazard noted.

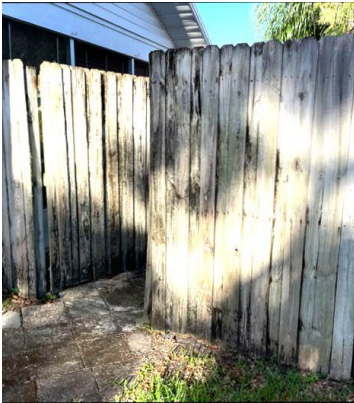
Fence was damaged.

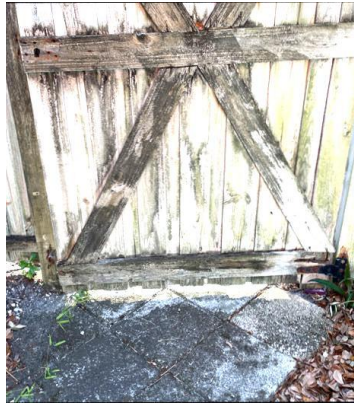
Gate was damaged

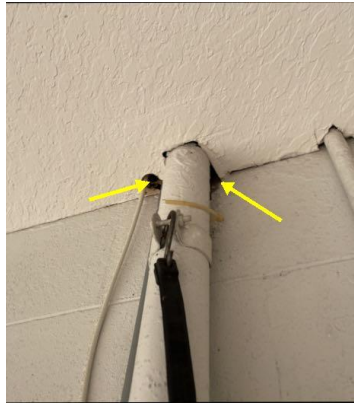
Ceiling seam separation was visible.

Holes/gaps should be repaired with fire-rated material.

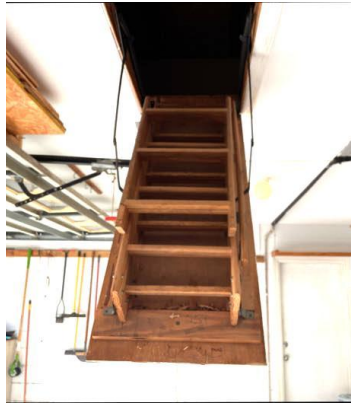
Attic pull down ladder was not fire-rated. (See NACHI Standard of Practice article - <https://www.nachi.org/inspectingresidential-attachedgarages.htm>).

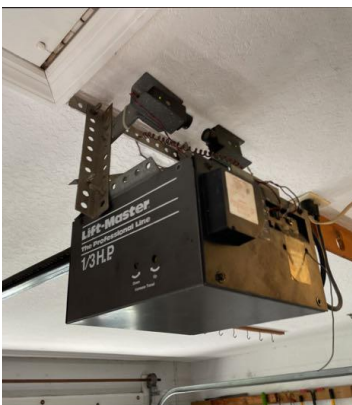
Electronic eye safety feature did not operate when tested.

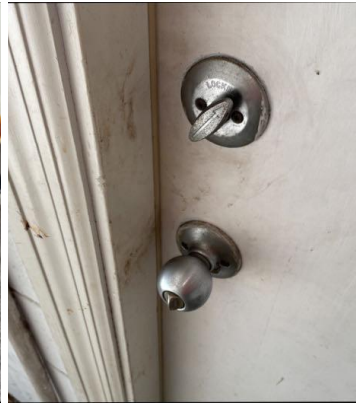
Lock was damaged.

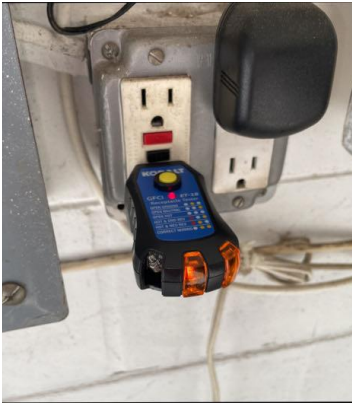
GFCI (Ground Fault Circuit Interrupter) outlet(s) was damaged at garage outlets.

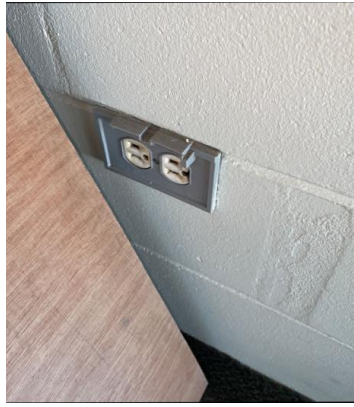
Weatherproof covers were damaged/missing at exterior outlet(s).

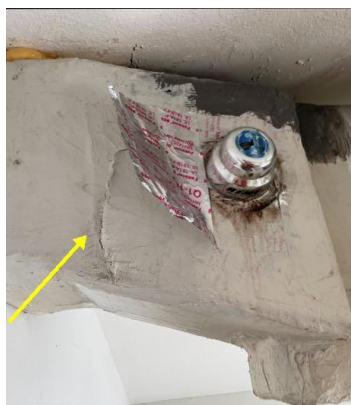
Gaps/damage at the plenum should be sealed.

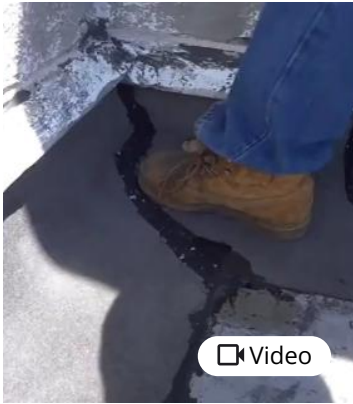
Roof water damage

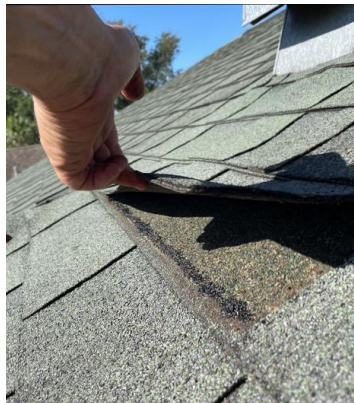
Loose shingles near vent flashing

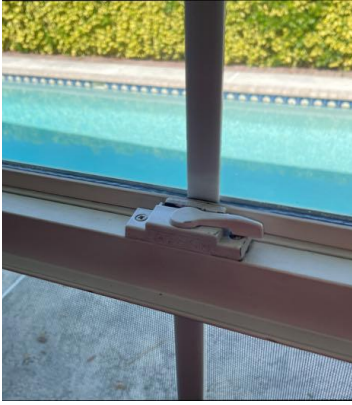
Locks were missing/damaged at family room

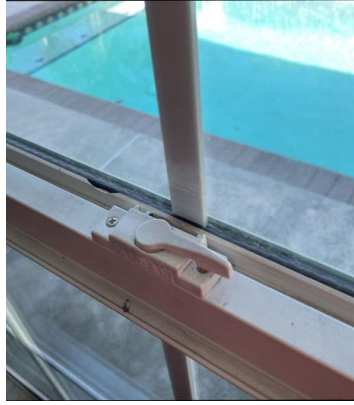
Locks were missing/damaged at family room

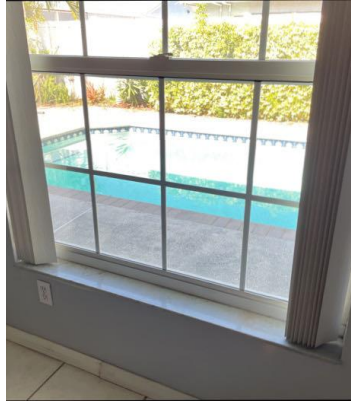
Window tension spring(s) were damaged - Utility room

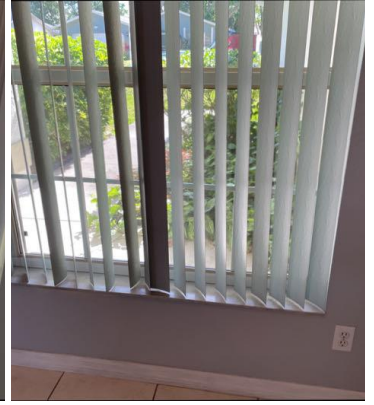
Window tension spring(s) were damaged - kitchen

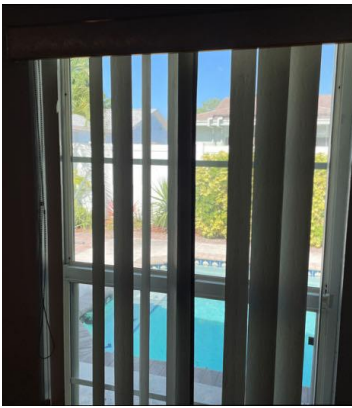
Window tension spring(s) were damaged - Living room multiple locations

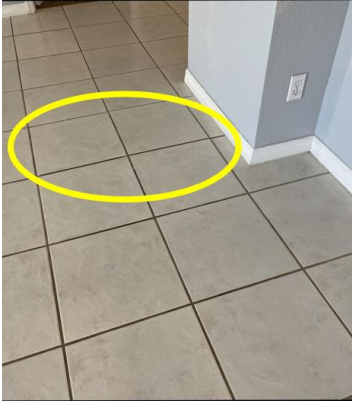
Tile flooring was disbonded at family room.  
Hollow sound can be heard when the flooring was tapped

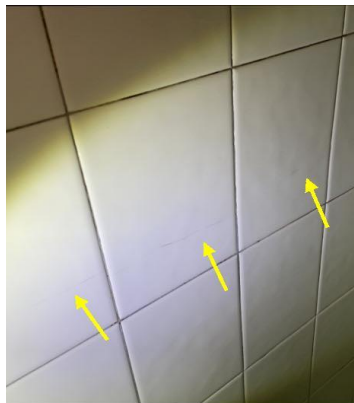
Cracked tiles were visible at primary bathroom
