**SAMPLE  
REPORT**

## Residential Home Inspection

123 Old Fashioned Tree Rd

Sample property | Inspection date: August 14, 2026

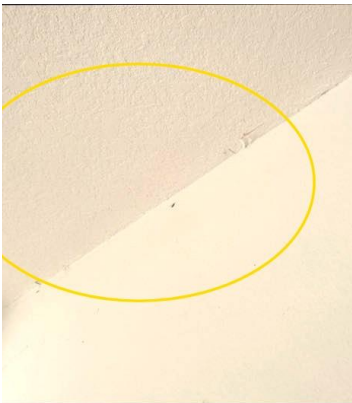
Ceiling seam separation was visible.

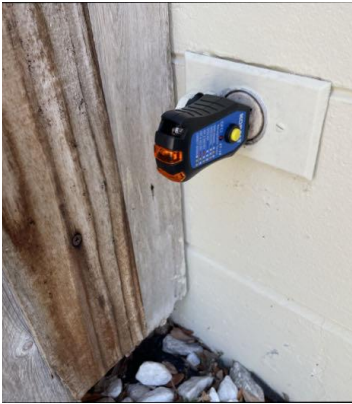
Outlet(s) were not operational at exterior.

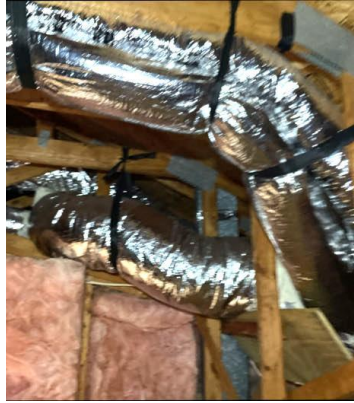
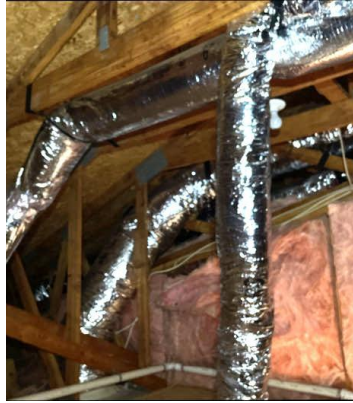
Flexible HVAC ductwork  
in attic

During inspection, numerous ducts were not fully visible, which limited a complete assessment. However, air leaks were detected at the visible connections, suggesting potential inefficiencies in the heating system distribution.

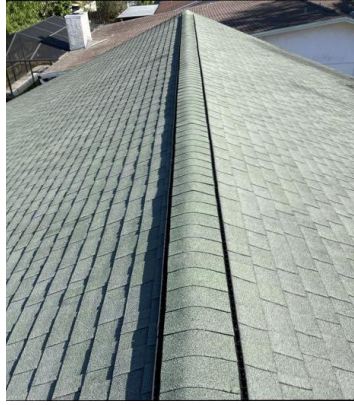
Roof water damage

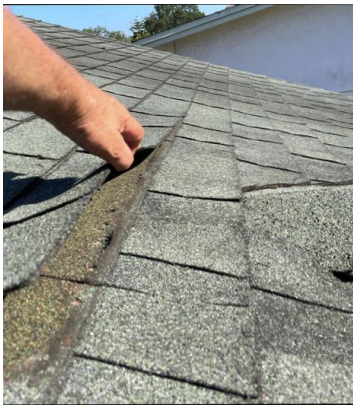
During the roof inspection, damaged and loose roofing materials were observed in multiple locations. These issues can potentially lead to water intrusion and further structural damage if not addressed promptly. It is recommended that a qualified licensed roofer evaluates and repairs these areas to ensure the roof's integrity and longevity.

Lifted roof shingles at ridge

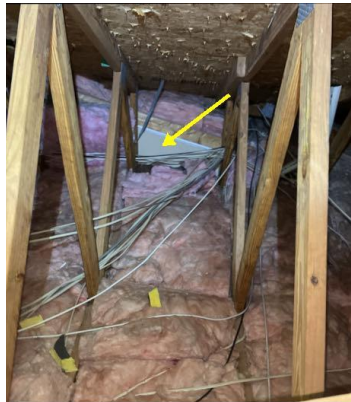
Electrical box exposed in attic insulation

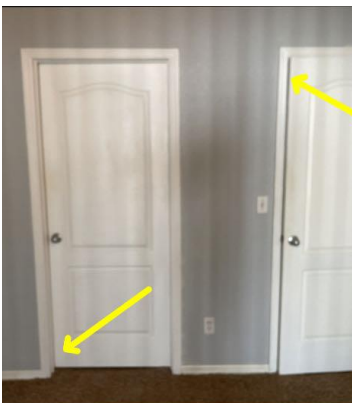
The interior door of the primary bedroom exhibits rubbing and sticking issues. This may indicate misalignment or changes in the door frame or structure.

Door rubbed/stuck at primary bedroom

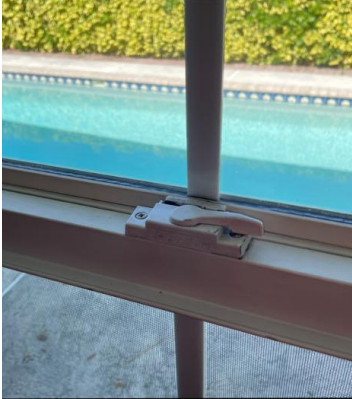
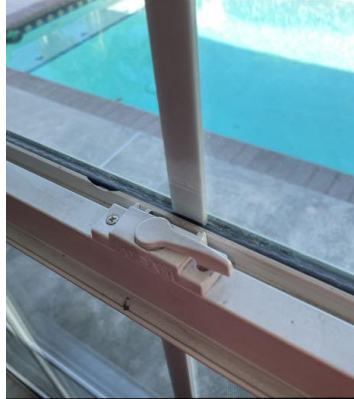
The window tension springs were damaged in multiple locations, potentially affecting the functionality and safety of the windows. Additionally, several locks in the family room were either missing or damaged, which may compromise security in this area.

Locks were missing/damaged at family room

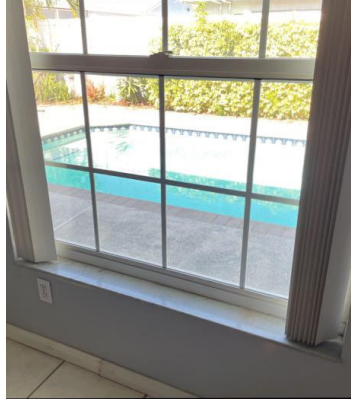
Window tension spring(s) were damaged - Utility room

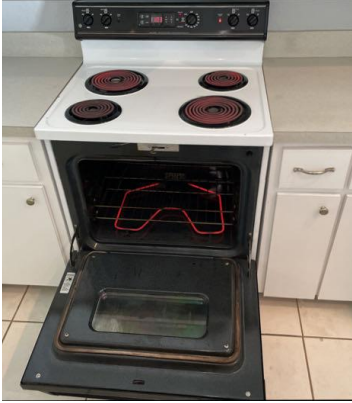
Oven light did not operate

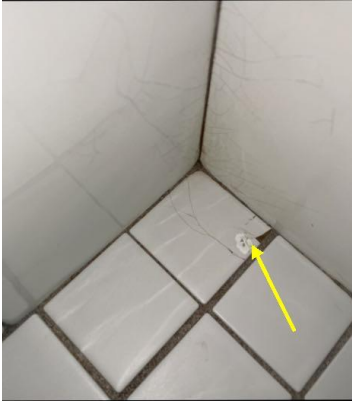
All bathroom shower enclosures require caulking or grouting to ensure proper sealing. In the primary bathroom, cracked tiles were observed, which may indicate potential water intrusion issues. Additionally, there is damage to the wall at the exterior of the shower enclosure in the primary bathroom, necessitating attention to prevent further deterioration.

Cracked tiles were visible at primary bathroom

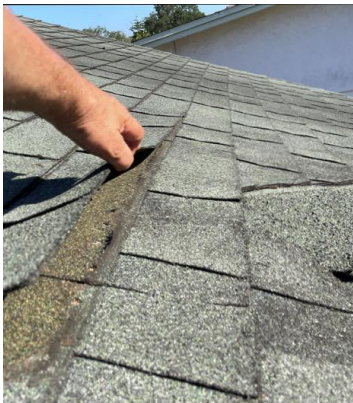
During the roof inspection, damaged and loose roofing materials were observed in multiple locations. These issues can potentially lead to water intrusion and further structural

Lifted roof shingles at ridge

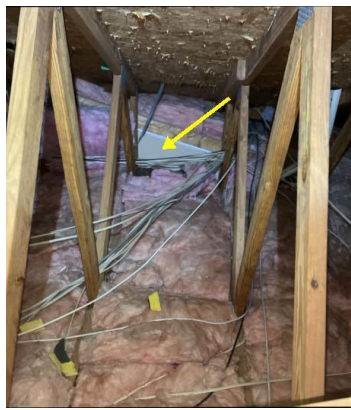
Electrical box exposed in attic insulation

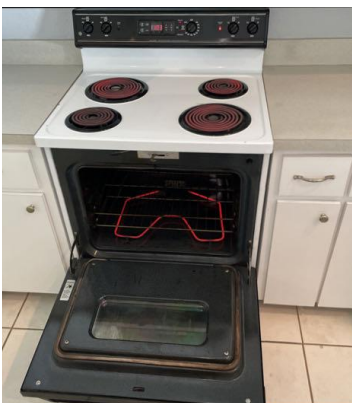
Oven light did not operate

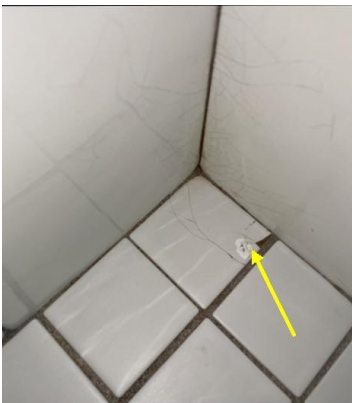
All bathroom shower enclosures require caulking or grouting to ensure proper sealing. In the primary bathroom, cracked tiles were observed, which may indicate potential water intrusion issues. Additionally, there is damage to the wall at the exterior of the shower enclosure in the primary bathroom, necessitating attention to prevent further deterioration.

Cracked tiles were visible at primary bathroom
