**SAMPLE  
REPORT**

## Residential Home Inspection

123 Old Fashioned Tree Rd

Sample property | Inspection date: August 14, 2026

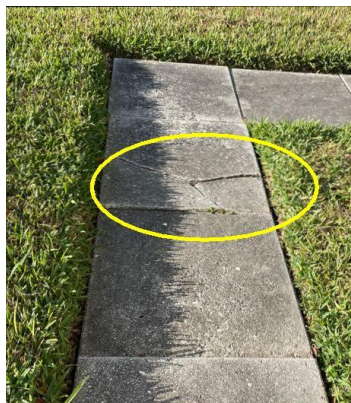
The walkway has significant large and displaced cracks, which could pose potential safety concerns. Additionally, both the driveway and walkway surfaces have areas of raising or settling, creating noticeable trip hazards.

Walkway had large and displaced crack(s) visible.

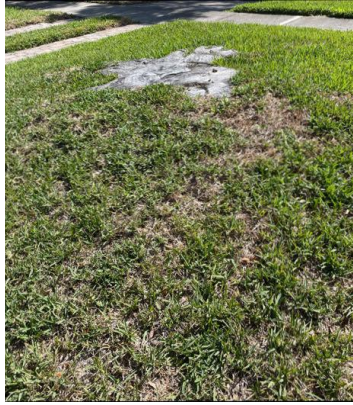
The landscaping and vegetation around the property are poorly maintained and overgrown, which may lead to potential issues such as moisture retention near the foundation. Additionally, there are two large tree stumps present in the front yard, which could contribute to future foundation concerns if not addressed.

Two large tree stumps are present in the front yard

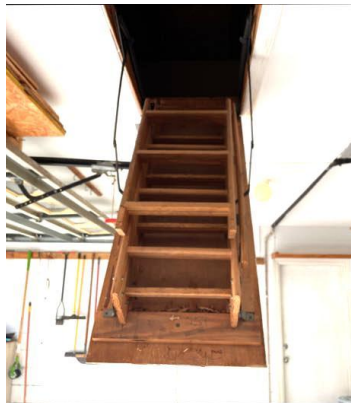
Attic pull down ladder was not fire-rated. (See NACHI Standard of Practice article - <https://www.nachi.org/inspectingresidential-attachedgarages.htm>).

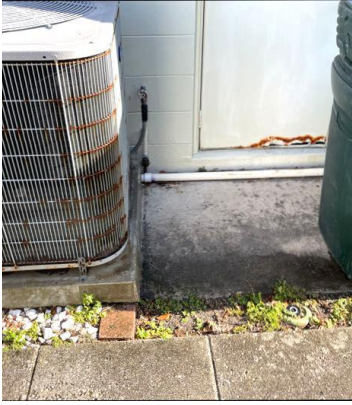
Sprinkler heads should be adjusted for proper coverage. Sprinkler spraying on structure and appliances.

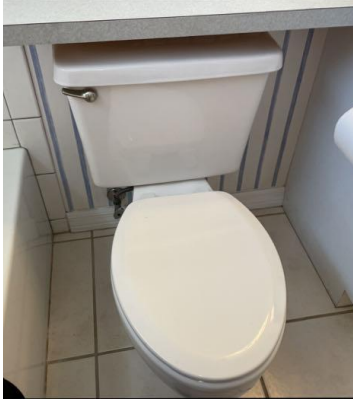
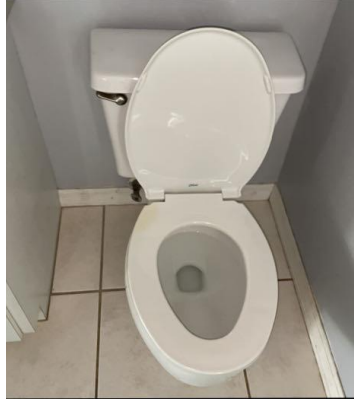
Toilet was loose at the floor at all bathrooms.

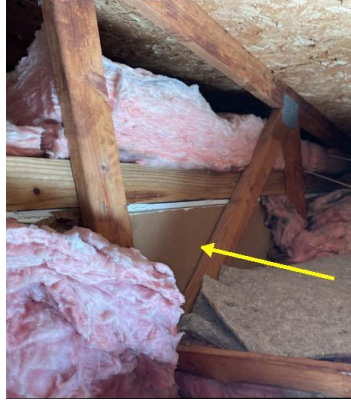
During the inspection of the attic, visibility was significantly limited due to insulation, ductwork, and the structure's height. It was noted that the insulation had been moved or disturbed in several areas, resulting in low coverage spots.

Insulation had been moved/disturbed, leaving low coverage areas

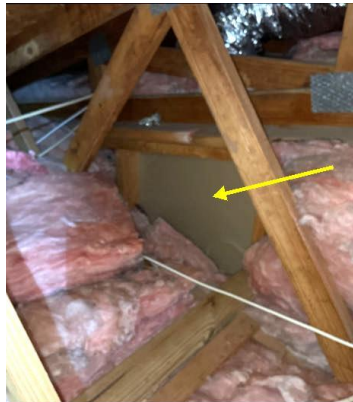
Insulation had been moved/disturbed, leaving low coverage areas

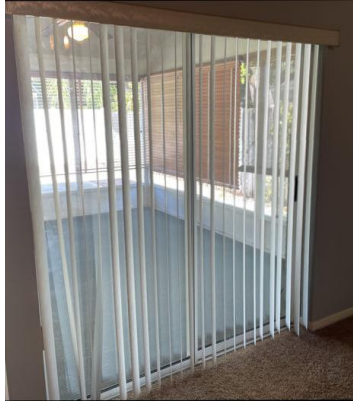
The tracks and rollers on the sliding doors require cleaning, adjustment, and lubrication. Regular maintenance in these areas is essential to ensure smooth and proper operation.

Tracks and rollers on the sliding doors should be cleaned, adjusted and lubricated for proper operation on a regular basis.

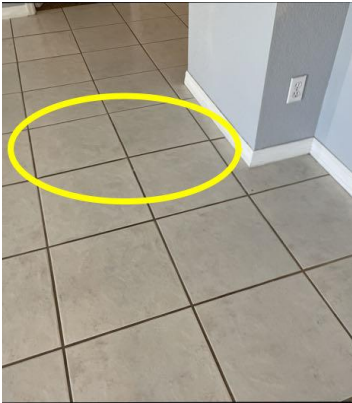
Tile flooring was disbonded at family room.  
Hollow sound can be heard when the flooring was tapped

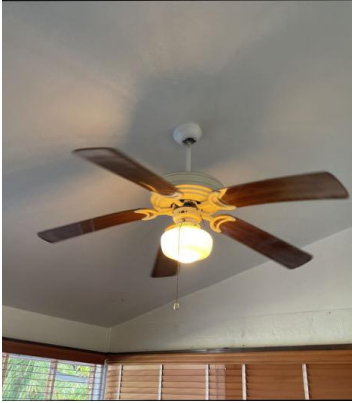
The ceiling fan in the living/family room shows noticeable wobbling when in operation. This may be due to imbalanced blades, improper mounting, or loose connections.

The ceiling fan(s) wobbled  
at the living/family room

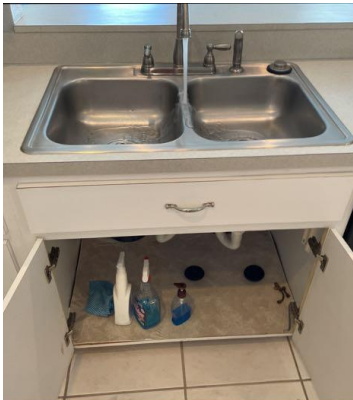
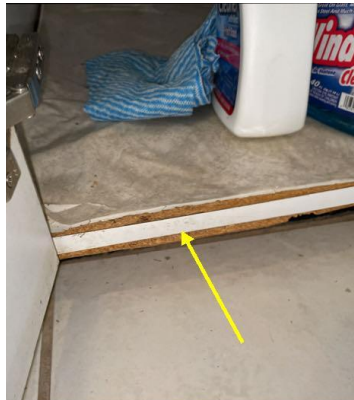
Moisture stains and signs of damage were observed under the kitchen sink. This indicates a past or ongoing leak that has affected the area. It's important to address the source of moisture to prevent further deterioration and possible mold growth. Regular monitoring and maintenance are crucial.

Moisture stains

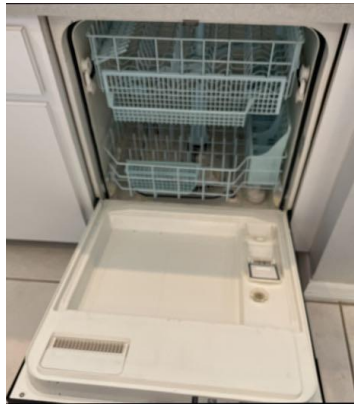
Dishwasher not operable

Dishwasher door - Open

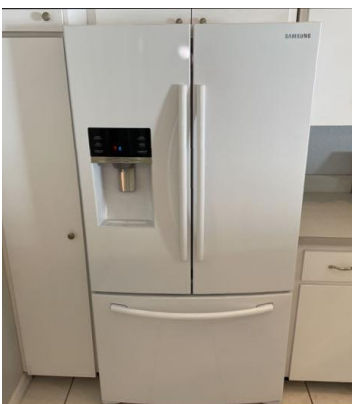
The refrigerator's drinking water supply is operational; however, the icemaker is not producing ice. Further evaluation may be necessary to determine the cause of this issue.

Icemaker did not supply ice

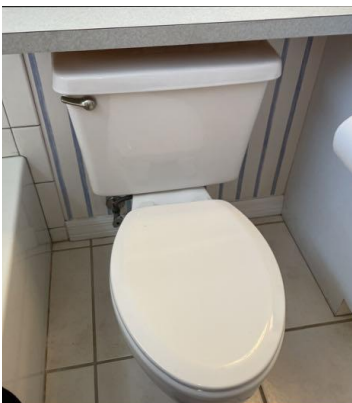
All bathrooms have toilets that are loose at the floor. This indicates a potential issue with the stability and may lead to leaks or damage if not addressed. It's important this condition be reviewed further to ensure proper function and integrity of the seal and flooring.

Toilet was loose at the floor at all bathrooms

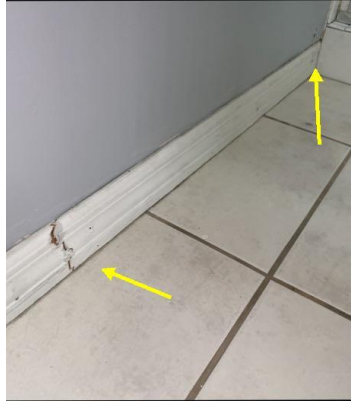
Wall at the exterior of shower enclosure was damaged at the primary bathroom

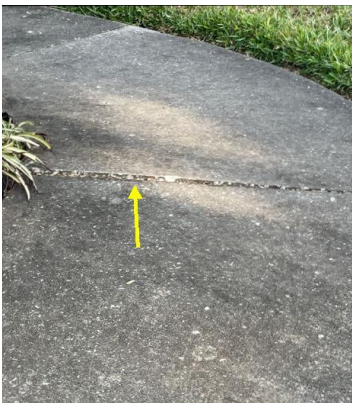
The walkway has significant large and displaced cracks, which could pose potential safety concerns. Additionally, both the driveway and walkway surfaces have areas of raising or settling, creating noticeable trip hazards.

Driveway/Walkway surface was raised/settled.  
Trip hazard noted.

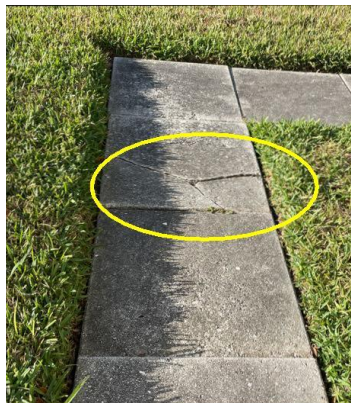
Walkway had large and displaced crack(s) visible.

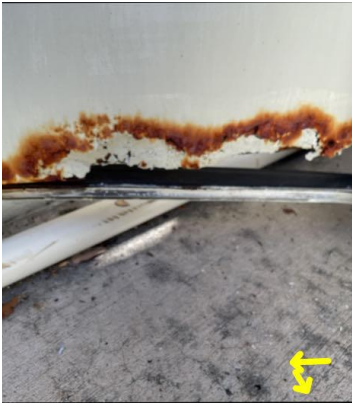
Moisture damage was observed on both the door and door jamb. Additionally, the lock was found to be damaged. These issues may compromise the door's functionality and security. Further assessment might be needed to determine the extent of the moisture impact and necessary repairs.

Moisture damage was visible at the door and/or door jamb.

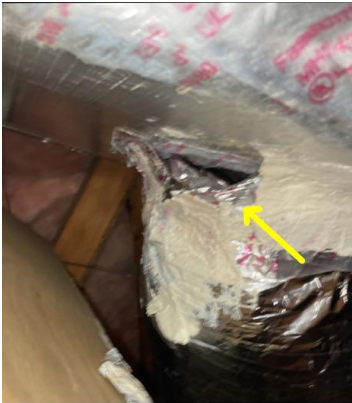
Air leaks detected at visible connections in the heating system distribution.

Air leak

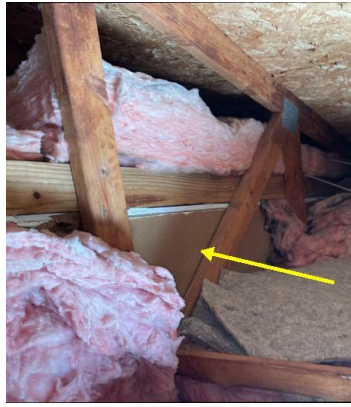
Insulation had been moved/disturbed, leaving low coverage areas

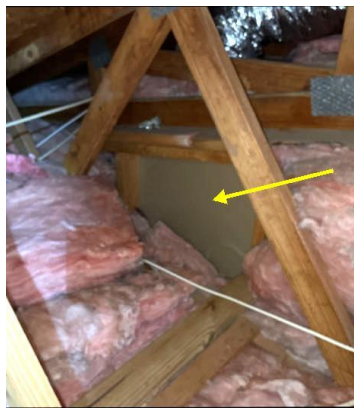
Insulation had been moved/disturbed, leaving low coverage areas

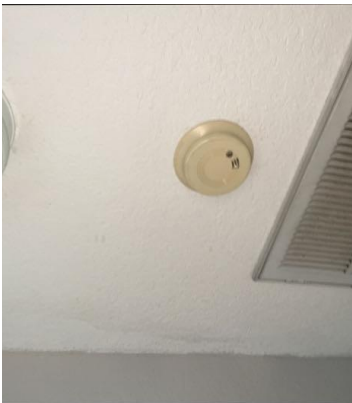
Smoke detector(s) did not respond when tested at Hallway

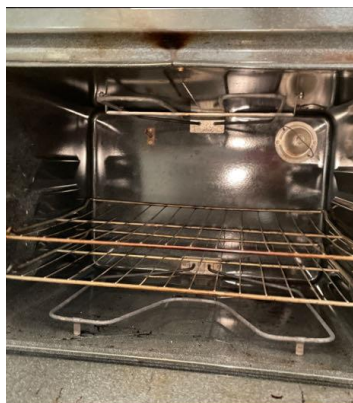
Oven was not functioning properly. No broiler. No Light

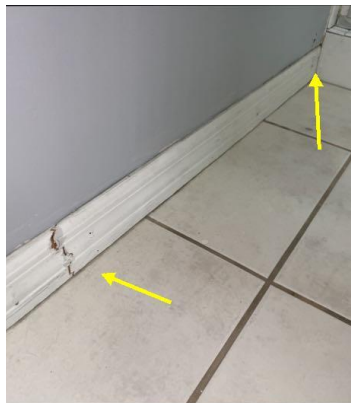
All bathroom shower enclosures require caulking or grouting to ensure proper sealing. In the primary bathroom, cracked tiles were observed, which may indicate potential water intrusion issues. Additionally, there is damage to the wall at the exterior of the shower enclosure in the primary bathroom, necessitating attention to prevent further deterioration.

Wall at the exterior of shower enclosure was damaged at the primary bathroom
